AUGUST 1955

The Approach

THE NAVAL AVIATION SAFETY REVIEW

NAVAER 00-75-510

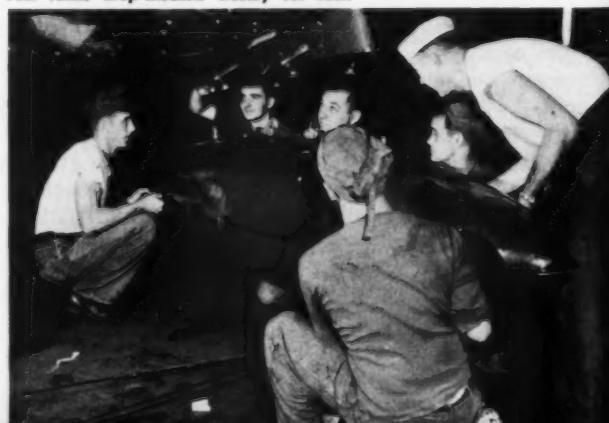
Fuel tanks drop-checked weekly for rust.

Fleet Air Guam—Following recent tests the NAS here has adopted a policy of drop checking (on the ground) external droppable fuel tanks weekly. Several instances have been observed during these tests in which the bomb racks supporting the fuel tanks had become so badly corroded within a short period of time that they would not release. In one case even the emergency hydraulic release failed to free the tank. The maintenance and material committee pointed out that all maintenance officers should check their maintenance programs to insure that all possible malpractices are eliminated, and directed attention to the following: TO 49-54, Daily draining of aircraft fuel systems to remove water and to detect foreign matter; TO 1-55, Cleaning of hydraulic shock struts and actuating cylinders; TO 48-54, Utilization of aircraft engine fuels.

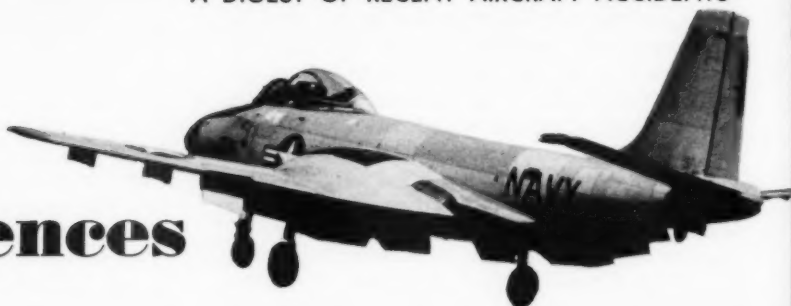
STALL/SPIN—Returning from a three-plane familiarization flight in a F2H-3, the pilot made a slow approach, the airplane settling into the ground approximately 15 feet short of the runway, striking the ground in a nose-high, left wing low attitude. The gear was torn from the plane on impact. Progressive overhaul damage occurred as the aircraft slid down the runway in a slight arc. No injury to pilot.

The investigation revealed that the pilot, from the 90-degree position on, made his approach too slow. He did not realize the dangerous altitude and attitude of the aircraft until too late, and evidently no corrective action was ever taken. By retarding the throttles at a slow speed, the pilot caused the aircraft to enter a partially stalled condition.

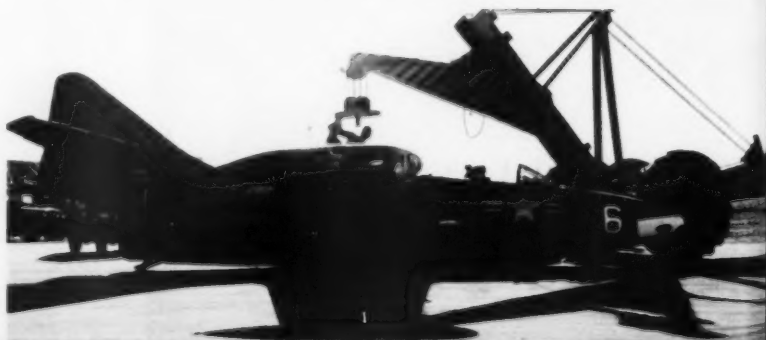
Pilot was returning to base after day simulated interdiction in his F9F-5. After break, and a 180-degree position, with approximately 1000 feet of altitude, the pilot noted a loss of aileron boost. He discovered that in retarding the throttle he had pulled it around the idle stop to the closed position. The pilot attempted no airstart. He turned on the emergency hydraulic pump and put the gear handle down. The pilot continued his approach and touched down with gear, flaps and divebrakes up at the 2000-foot mark on the runway. The aircraft suffered overhaul damage, class B, the pilot none.

did not use cartridge airstart, which it is believed would have been successful. It is further believed that actuation of the emergency air bottle to complete lowering of the gear, would have been successful time and space-wise, since the plane first touched down 2000 feet from the beginning of the runway. Pilot was commended for excellent airmanship in getting aircraft down safely in view of his limited experience. However, all pilots are to be cautioned about careless handling of vital controls, such as the throttle. In view of the number of such accidents, the board recommended that designers attempt to provide a more positive mechanical device to prevent inadvertently putting the throttle in the cut-off position. ●

It was a nice break and approach until he pulled the throttle around the horn.

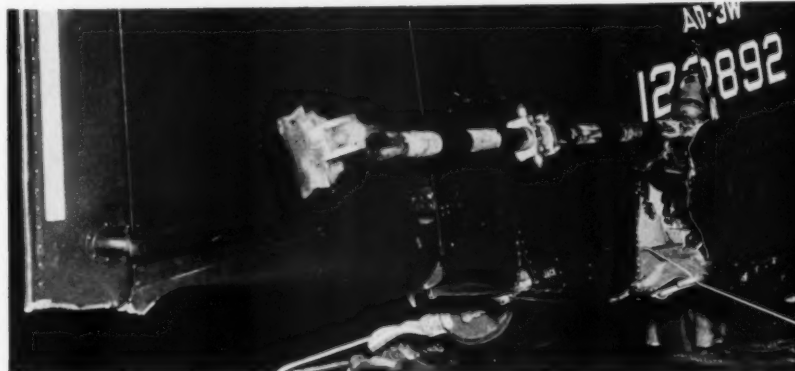
aircraft continued up the center of the flight deck with the arresting hook clear of the deck and engaged No. 2 and 3 barriers. Strike damage resulted to the aircraft.

The board concluded that the pilot's inexperience was the cause of his overcorrection in diving for the deck after the

A dive for the deck and an abrupt flare washed out this AD.

cut. It was recommended that each pilot be continually warned of the dangers of trying to get on the deck too fast, either by diving or easing throttle while in the groove. Constant supervision of all pilots landing techniques while doing FCLP was also recommended. ●

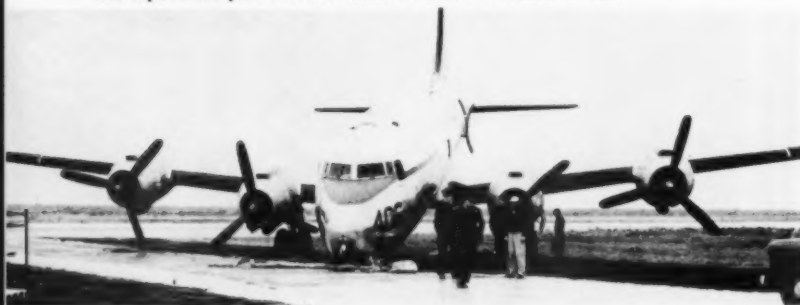
This experienced pilot failed to utilize all means of rollout control.

3. It was recommended that multi-engine training syllabi include an addition to the after-landing checklist of brakes available and steering available.

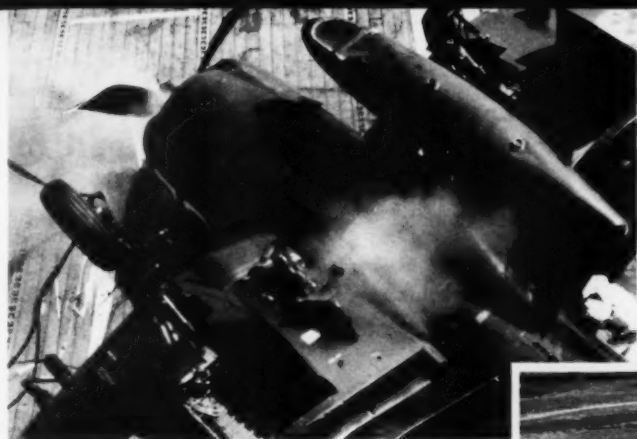
Crashed Corsair pilot survived when hardhat absorbed blow.

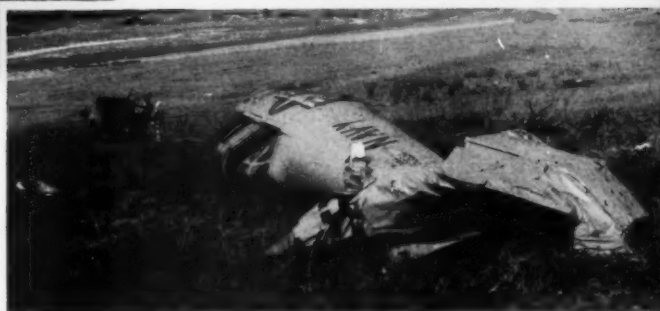
Safety equipment enabled the pilot of cartwheeled 5NJ to walk away.

An AF-2S lost engine power after takeoff, forcing the pilot to make an emergency wheels-up landing in grass field. The aircraft tore through wire fence and posts, skidded through a six-foot thick sea wall four feet high, simultaneously tearing out a section of telephone line. The engine was partially broken from the fuselage. The safety belt and shoulder harness held the pilot securely in his seat. Use of the protective helmet prevented serious or fatal injury since a severe blow occurred to the helmet when the aircraft engine mount and fuselage buckled on impact.

The blow was sufficient to crack the helmet at the forehead level and transmit a blow to the pilot's forehead resulting in only a minor bump on the pilot's head. The proper use of safety equipment also definitely prevented serious injury to the passenger.

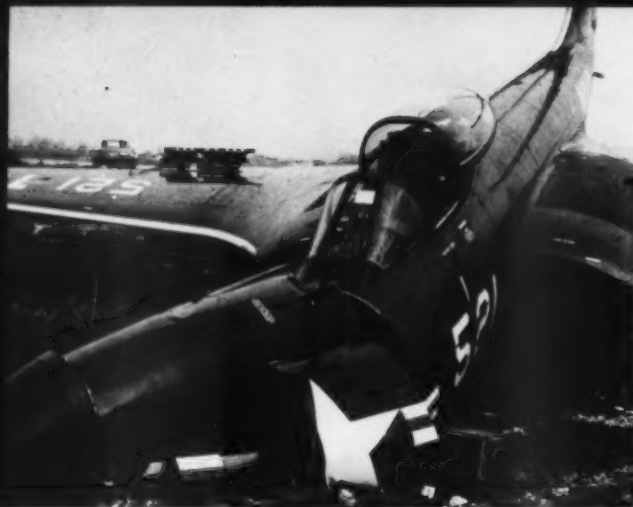
This Banshee fell victim to a neglected teleflex check.

The port engine would not cut off with the throttle in the OFF position because the telescopic unit of the engine control had separated at the quadrant end of the control. The separation was caused by the jam nut loosening al-

Add teleflex check to your Banshee inspection form.

(3) The inspection of Teleflex connections be incorporated in all major and intermediate inspection forms.

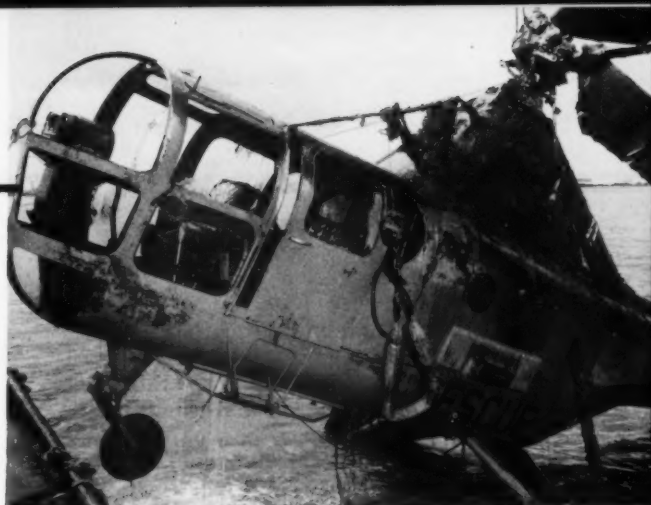
Vacuum pump drive gear spacer was too thick.
